NRL Memorandum Report 656

TANKAGE FAILURES OF AEROBEE-HI AND VANGUARD ROCKETS

J. E. Srawley
METALLURGY DIVISION

December 1956

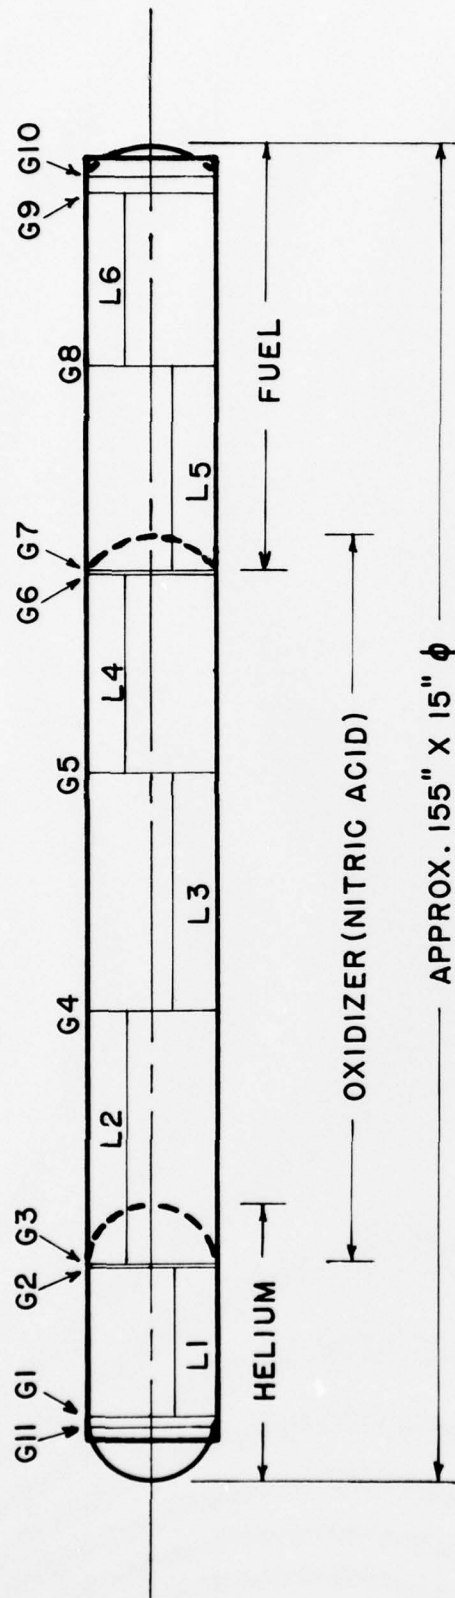
Figure 1 - Schematic Drawing of Aerobee - Hi Tank Assembly Showing Locations of Principal Welds

A schematic drawing of the Aerobee - Hi, showing the locations of some of the welded joints, is shown in Figure 1. Details of the weld joints G2 and G3 are shown in Figure 2. The brief description given in the manufacturer's specification AES-A2821.6a reads as follows:

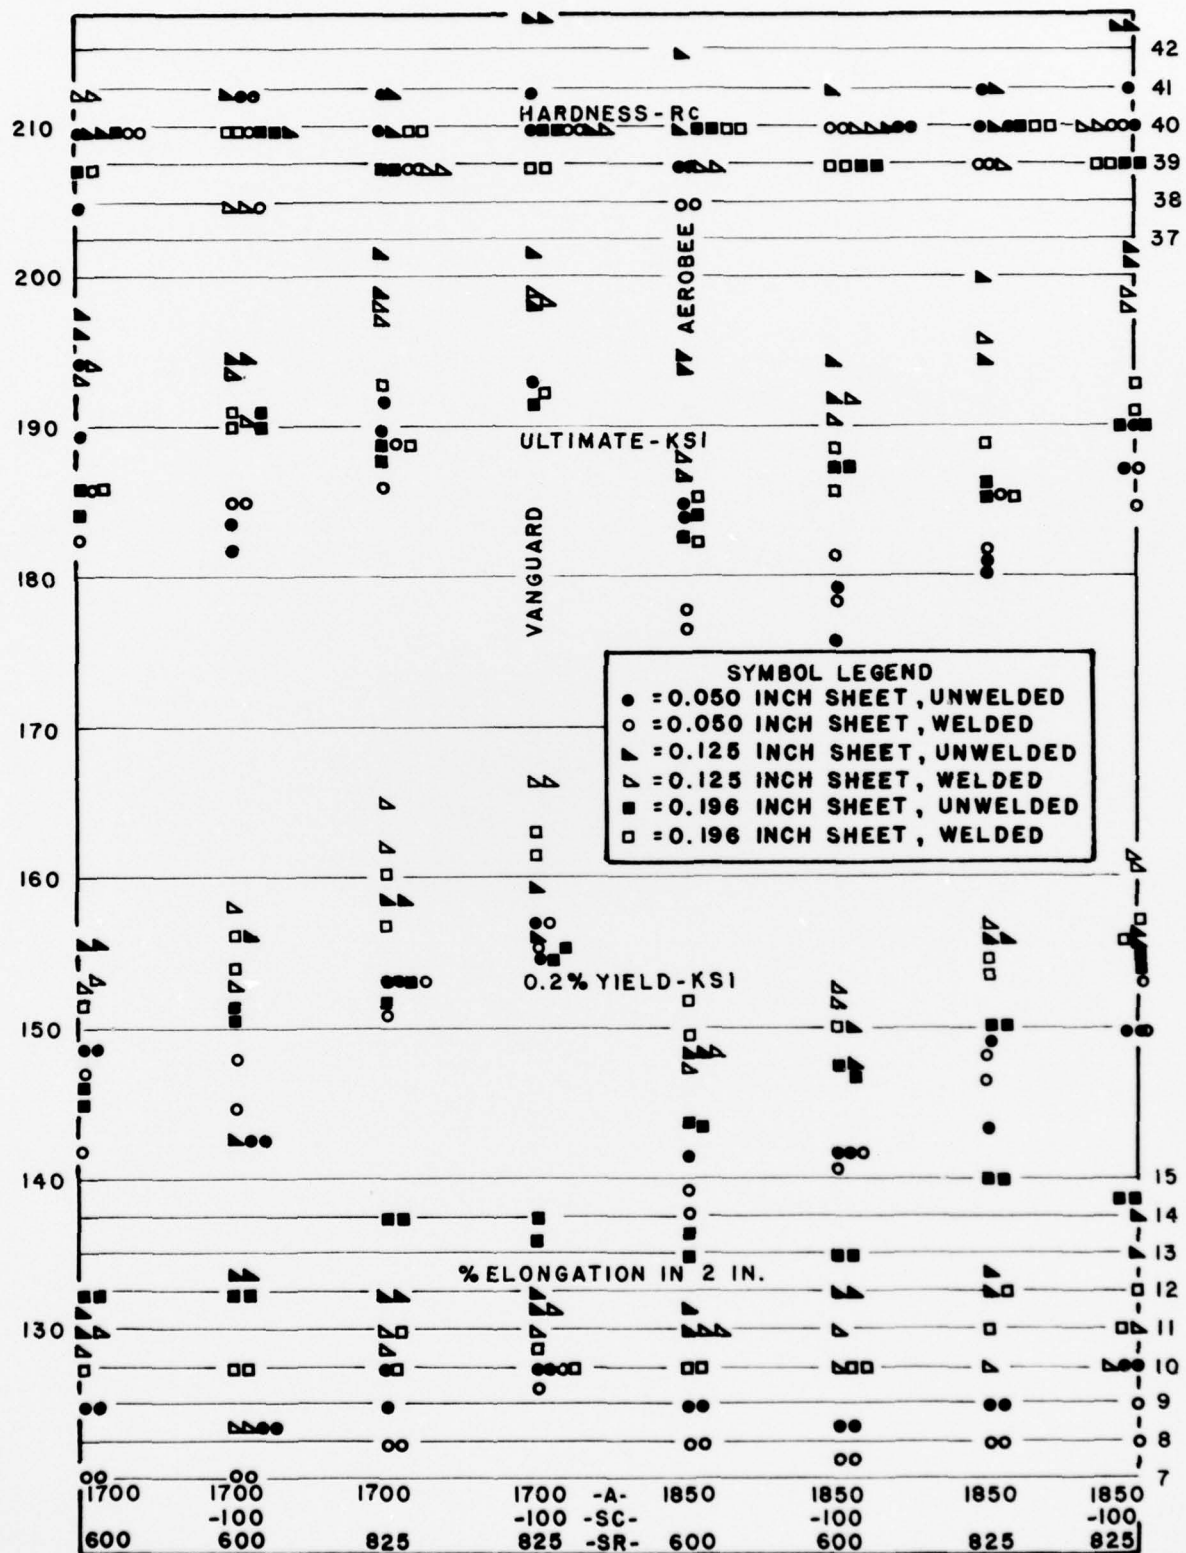
Figure 18 - Heat Treatment Condition vs Properties Type 410

The superior tensile properties for the Vanguard heat treatment have been substantiated on 11 lots of material, including three different thicknesses, by A. Co. The properties obtained in tensile tests of welded and not-welded test pieces are shown in Figure 18 for six different combinations of heat

treatment variables. The code at the bottom of each column of points in Figure 18 indicates austenitizing temperature, cold treatment and tempering temperature. Examination of this data indicates that little or none of the improvement is associated with the subzero treatment, whereas the effect of the lower austenitizing temperature and the higher tempering temperature both contribute to improve the yield strength. Ductility does not appear to depend strongly on the heat treatment variables, although there does appear to be an average improvement in Elongation of 1% between Aerobee and Vanguard.
